## Ground fault tracing: CT magnetization

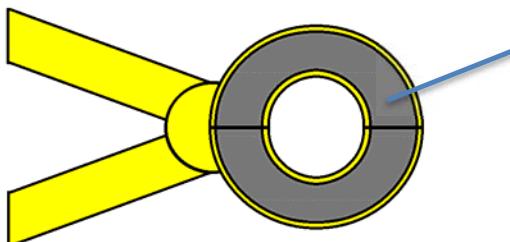
The iron core will have wire wrapped around it in order to transfer an AC signal. However, a DC signal will magnetize the iron core.

When tracing ground faults on ungrounded DC systems, one should not assume that there will be no DC current flowing through the circuit. If a current clamp (CT) is placed on a line with DC current, the DC current will cause the CT, namely its iron core, to magnetize. The higher the DC current, the stronger the magnetization will be.

This can make removing the CT quite difficult. The CT can be damaged in the process of removal. In some cases, the CT cannot be removed from the line.
