**DC ground fault locating
under difficult conditions
An AC coupling tale...**

CASE STUDY

DC ground fault locating in the presence of unwanted AC coupling

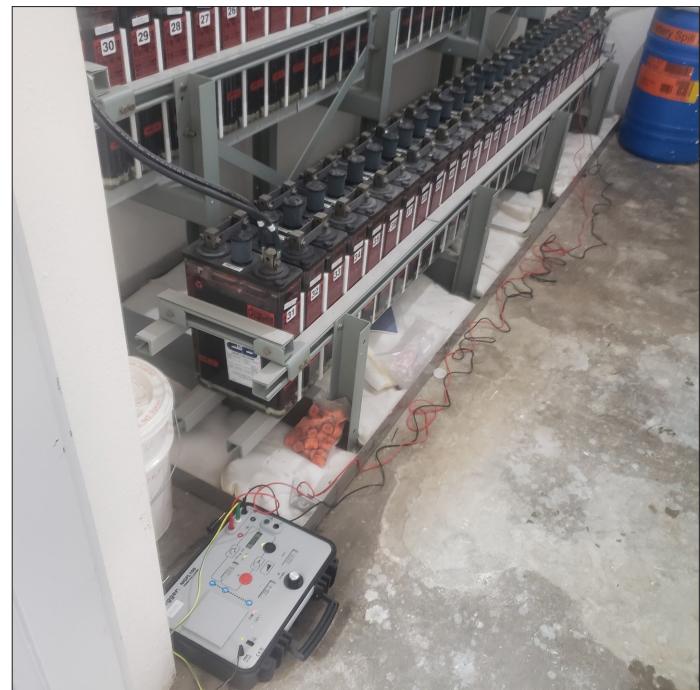
- TVA had used the Megger BGFT and a competitor's unit and traced the fault to the battery charger. They replaced the battery charger, and the fault did not go away.
- Megger assisted with the investigation. We placed a Megger MGFL100 on the string, and it did verify the presence of a negative ground fault (Figure 1).

Figure 1: the Megger MGFL confirming a negative ground fault on the battery string

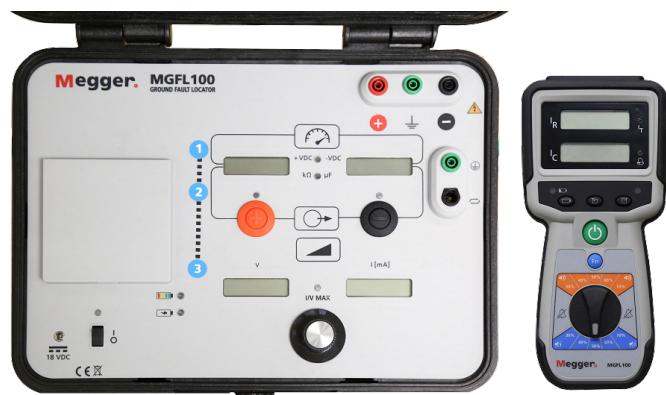
The MGFL100 is a battery ground fault locator. It can locate faults up to 400 kΩ. It can automatically identify real faults as well as leakage current. The until will alarm when it locates the real fault.

The MGFL100 also can trace faults on IT grounded AC systems. In addition, the MGFL100 receiver can be placed in a 50/60 Hz mode to trace any AC current.
