## Ground fault tracing: CT magnetization

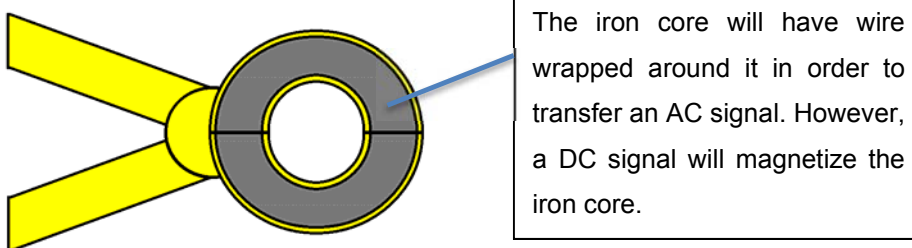
When tracing ground faults on ungrounded DC systems, one should not assume that there will be no DC current flowing through the circuit. If a current clamp (CT) is placed on a line with DC current, the DC current will cause the CT, namely its iron core, to magnetize. The higher the DC current, the stronger the magnetization will be.

This can make removing the CT quite difficult. The CT can be damaged in the process of removal. In some cases, the CT cannot be removed from the line.

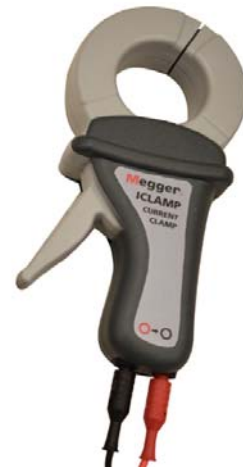
When tracing low level AC signals or pulses, the larger and purer the CT core, the higher its permeability and the more sensitive the CT will be. This makes the CT better at measuring these low currents used to trace faults. However, this also makes such a core more susceptible to magnetization. The MGFL100 CT is very sensitive but will not have any significant magnetization. This is because the core is made of a mu-metal compound. This core maintains high permeability but is far less prone to magnetization. If it is placed on an energised DC line, it can still easily be removed without any damage.

The mini active CT for the MGFL100 uses a flux gate technology, allowing a gap in the core. This also greatly reduces magnetization effects.

Using these current clamps will eliminate magnetization issues due to DC current.
