## Ground fault tracing: CT magnetization

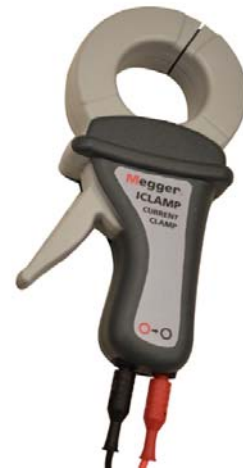
The mini active CT for the MGFL100 uses a flux gate technology, allowing a gap in the core. This also greatly reduces magnetization effects.

When tracing low level AC signals or pulses, the larger and purer the CT core, the higher its permeability and the more sensitive the CT will be. This makes the CT better at measuring these low currents used to trace faults. However, this also makes such a core more susceptible to magnetization. The MGFL100 CT is very sensitive but will not have any significant magnetization. This is because the core is made of a mu-metal compound. This core maintains high permeability but is far less prone to magnetization. If it is placed on an energised DC line, it can still easily be removed without any damage.

Using these current clamps will eliminate magnetization issues due to DC current.
