SONAVU+

THE **NEXT GENERATION** OF **ACOUSTIC IMAGING**

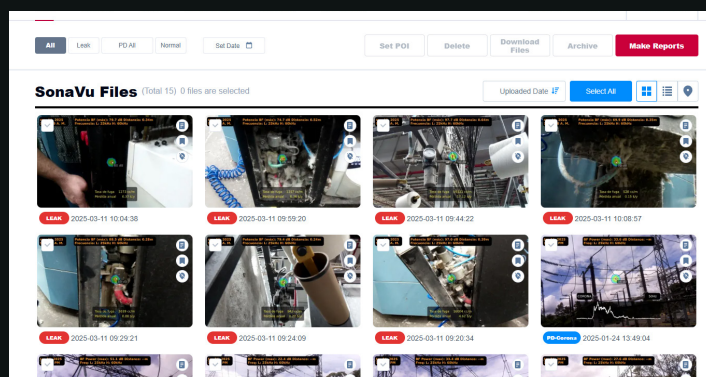
SonaVu InSights™ Reporting Application

The SonaVu InSights™ app transforms every inspection into a professional and actionable report. Every finding is documented with images and video, giving teams a clear visual record of leaks, discharges, or anomalies.

Defects are automatically ranked by severity and impact, while energy losses or downtime risks are calculated to prove ROI. All results are stored in one cloud-based hub, making them easy to access, organize, and track over time.

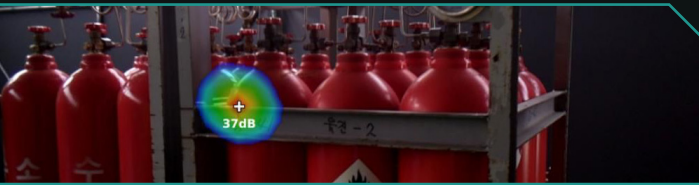
LEAK DETECTION

COMPRESSED AIR:

Acoustic imaging makes locating and visualizing leaks in real time easy... Even in noisy environments. When leaks are identified promptly, energy costs go down, system efficiency goes up, and compressed lifespan is extended.

FUGITIVE EMISSIONS:

Fugitive emissions threaten safety and compliance. But locating them is challenging due to low pressures and hazardous environments. SonaVu+ delivers sensitivity, range, and ATEX availability for safe, reliable inspections.

VACUUM PRESSURE:

Vacuum leaks create system inefficiencies, energy waste, and can potentially damage products and equipment. Acoustic imaging is a fast and reliable way to locate these leaks by visualizing the high frequency sounds they produce.
